**Draft Summary Report for the St. John's Lutheran
Hospital Rehabilitation Center and Helipad Field**

Draft Summary Report for the
St. John's Lutheran Hospital
Rehabilitation Center and Helipad Field
Libby Asbestos Site, Operable Unit 4

February 10, 2006

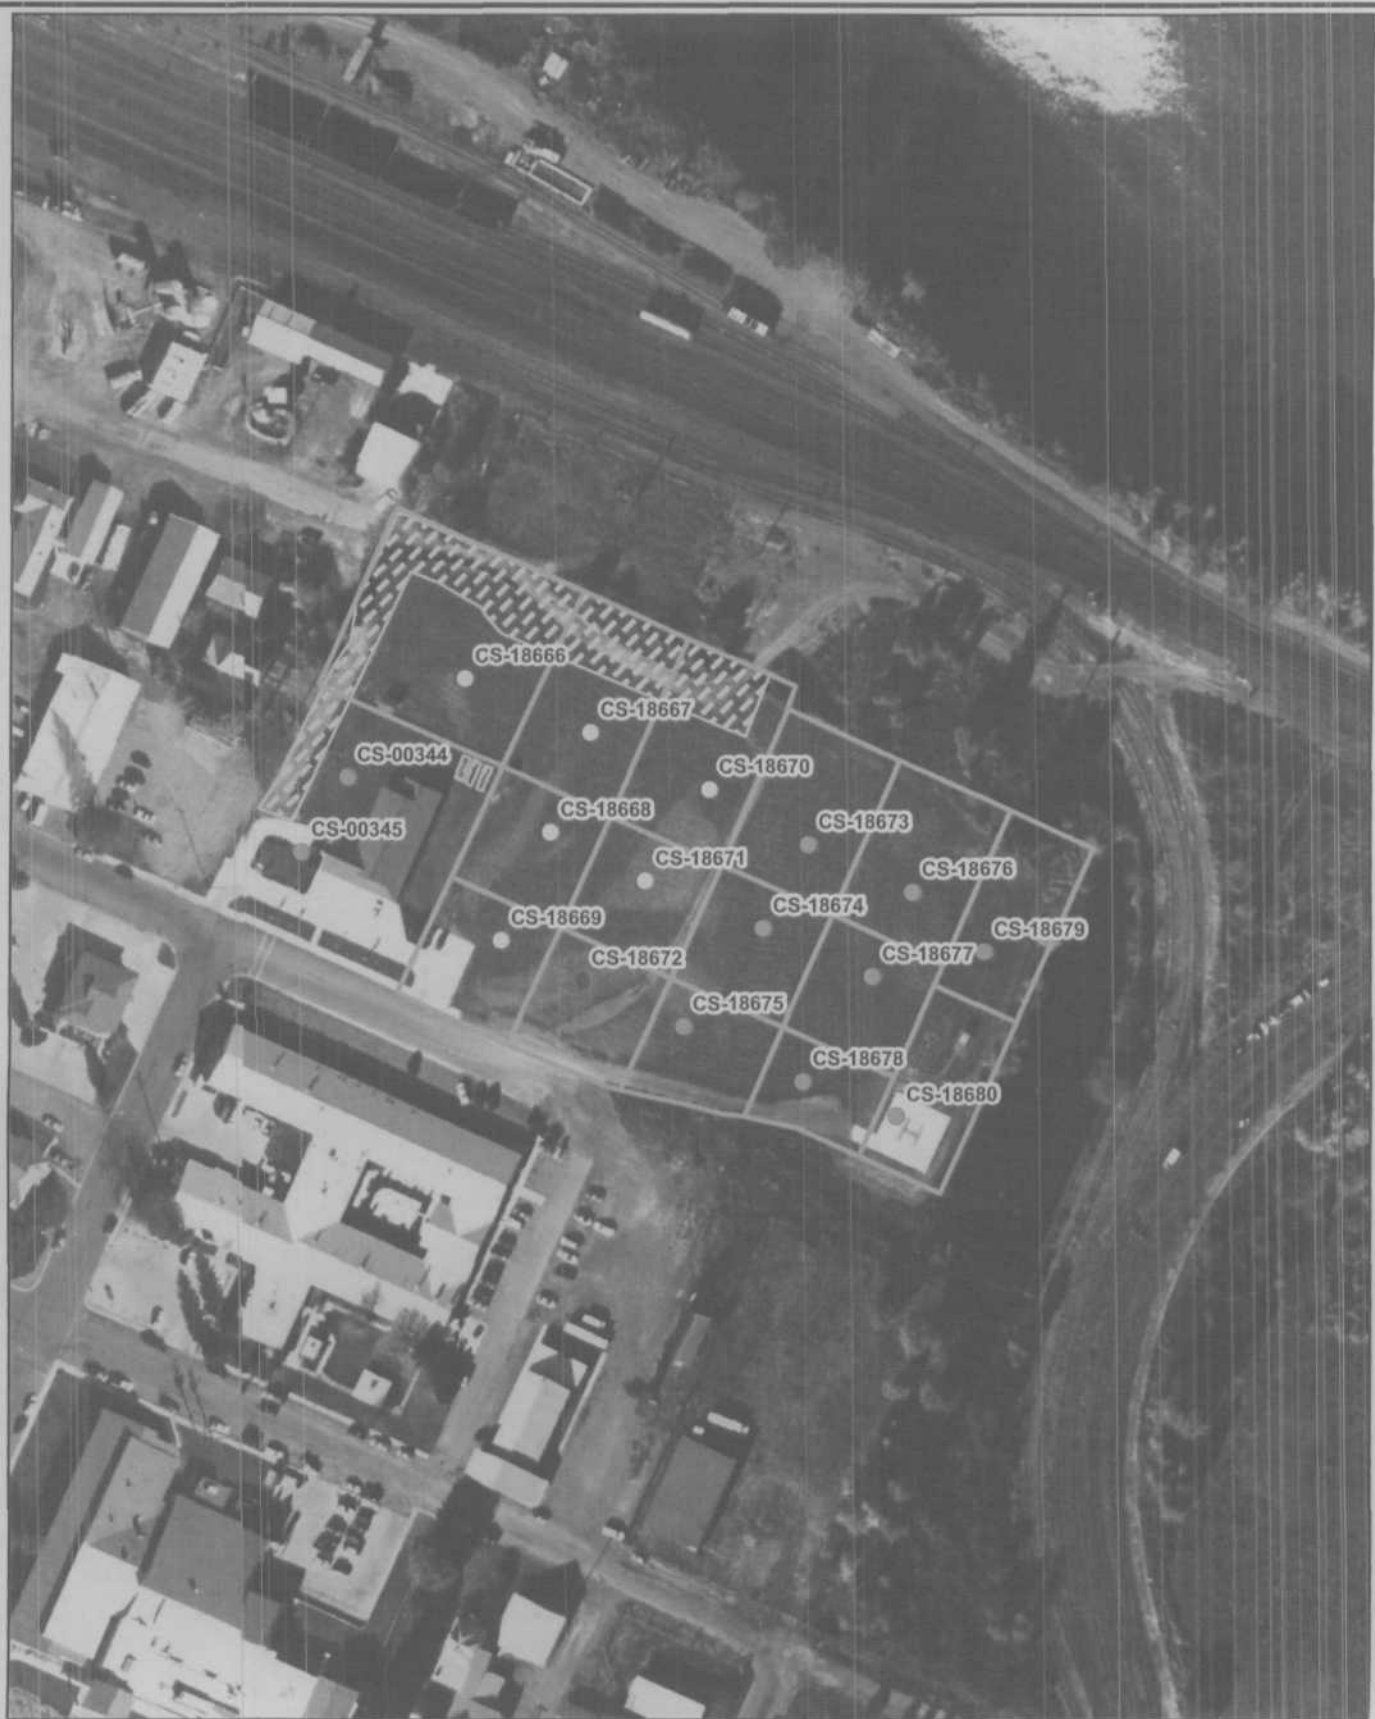
Figure 2-1
Sample Locations
and Results
308 East 2nd Street
Rehabilitation Center
and Helipad Field

Supplemental soil sampling was conducted on October 27, 2004 to characterize the field north and east of the rehabilitation center surrounding the Helipad. The field was divided into grids each approximately 100-feet by 100-feet or 75-feet by 150-feet, depending on site conditions. A five-point composite sample was collected from each grid square. In total, 15 soil samples were collected, at depths from 0 to 1 inch below ground surface. One sample had an LA asbestos content of less than 1%; six samples revealed trace (<0.2%) LA asbestos; and the remaining samples were non-detect for LA asbestos. Sample locations and results are presented in Figure 2-1.

During this sampling event, gross quantities of vermiculite were observed in the north and west corners of the field, and within the three planter boxes. Vermiculite was also observed in varying quantities within 10 of the 15 grids, as identified on the IFF sketch (Appendix A).

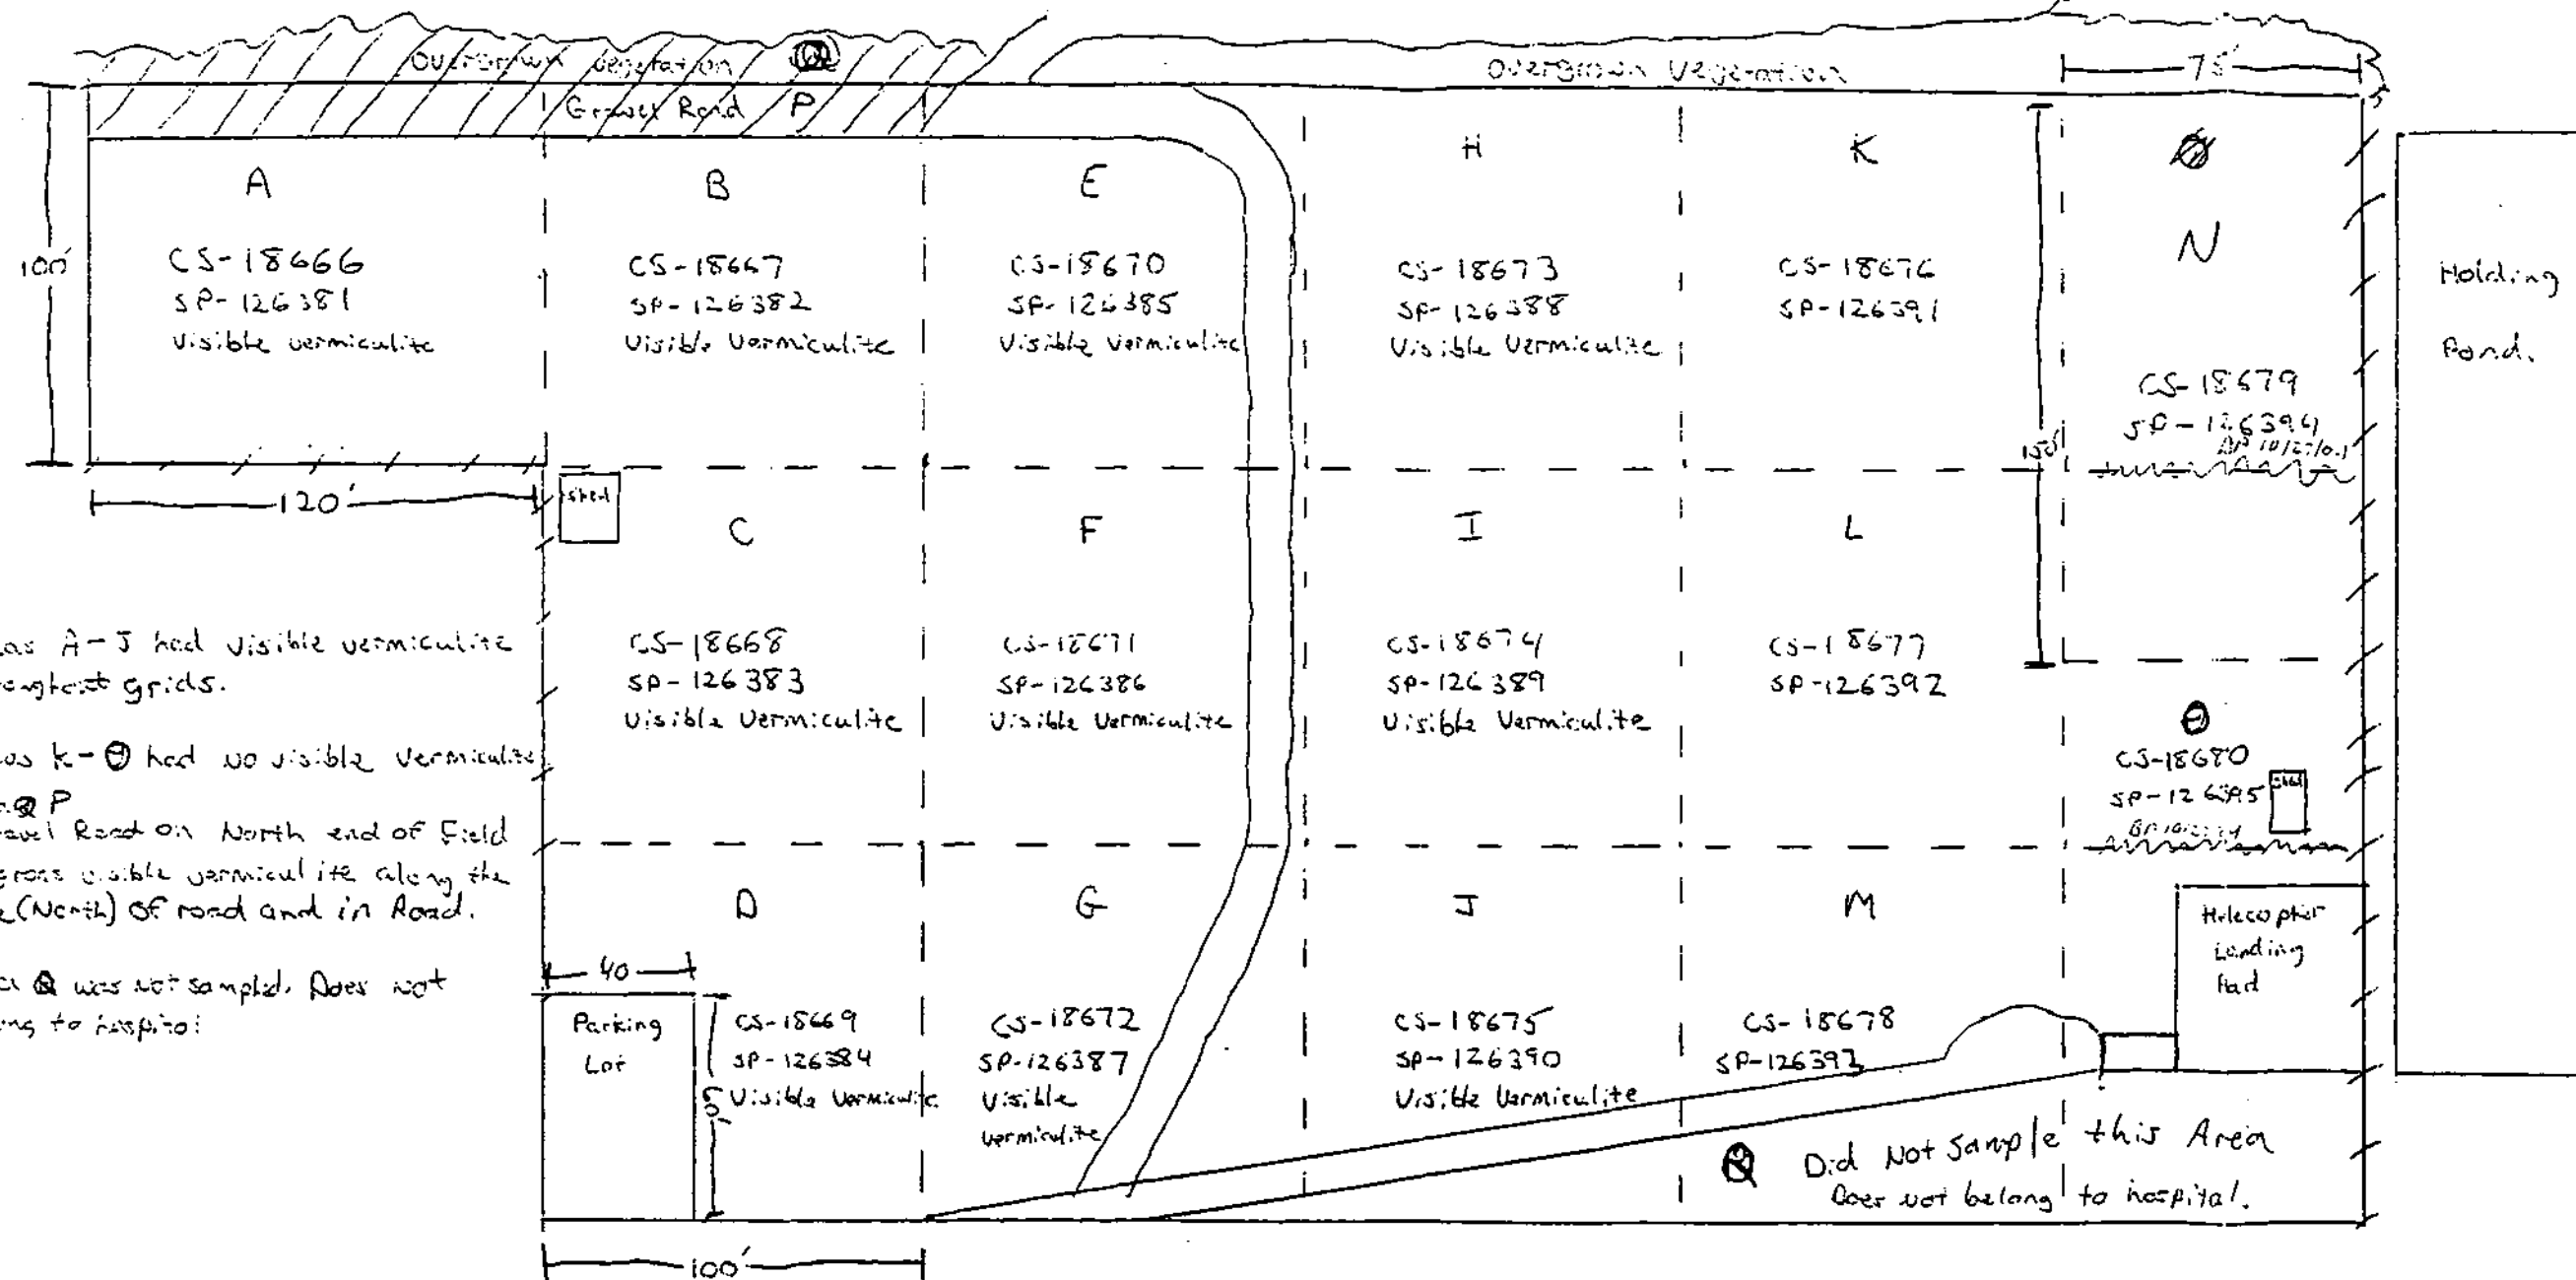
- Areas A-J had visible vermiculite throughout grids.

- Areas K-O had no visible vermiculite.
